AIRCRAFT ACCIDENT INVESTIGATION REPORT (COMPLETE)

CONTAINING ORIGINALLY EXCLUDED INFORMATION ON:

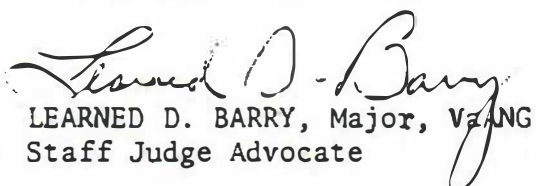
LEARNED D. BARRY, Major, USAF
Staff Judge Advocate

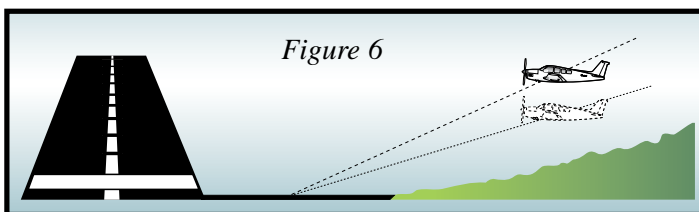
A final approach to an **unusually narrow** runway or an **unusually long** runway may produce the visual illusion of being too high. If you believe this illusion, you may pitch the aircraft's nose down to lose altitude. If this happens too close to the ground, you may land short of the runway and cause an accident (Figure 7).

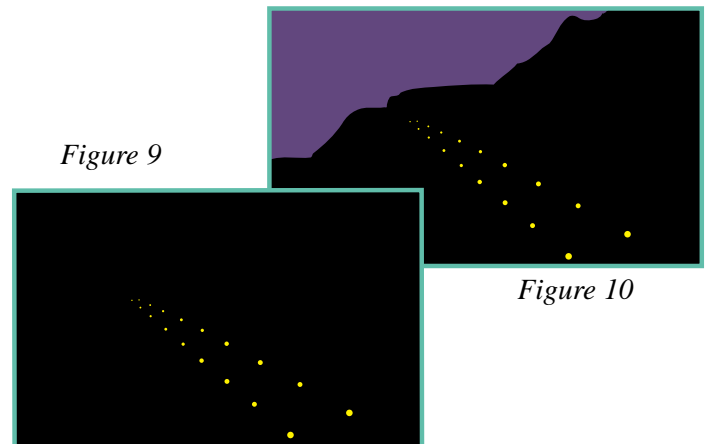
A particularly hazardous black-hole illusion involves approaching a runway under conditions with no lights before the runway and with city lights or rising terrain beyond the runway. Those conditions may produce the visual illusion of a high-altitude final approach. If you believe this illusion you may respond by lowering your approach slope (Figure 11).

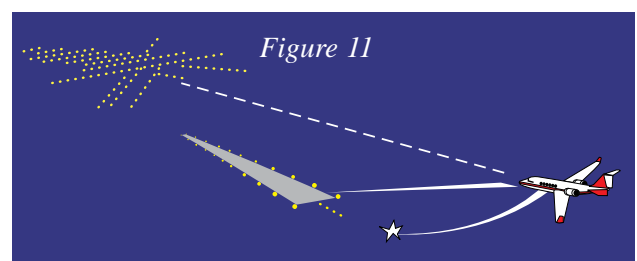
The **Autokinetic Illusion** gives you the impression that a stationary object is moving in front of the airplane's path; it is caused by staring at a fixed single point of light (ground light or a star) in a totally dark and featureless background. This illusion can cause a misperception that such a light is on a collision course with your aircraft (Figure 12).

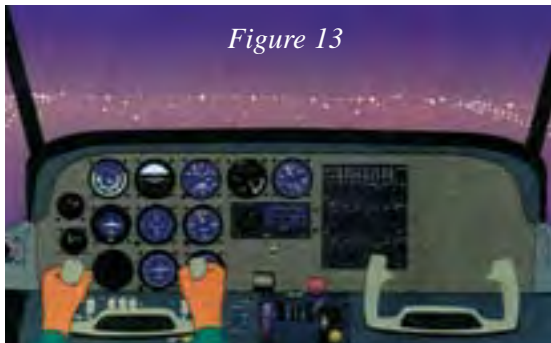
False Visual Reference Illusions may cause you to orient your aircraft in relation to a false horizon; these illusions are caused by flying over a banked cloud, night flying over featureless terrain with ground lights that are indistinguishable from a dark sky with stars, or night flying over a featureless terrain with a clearly defined pattern of ground lights and a dark, starless sky (Figure 13).
